Test Report No.: **01 220 CHN/T-1901185\_EN**

# Test Report

**Sample name:** Ringlock system scaffolding

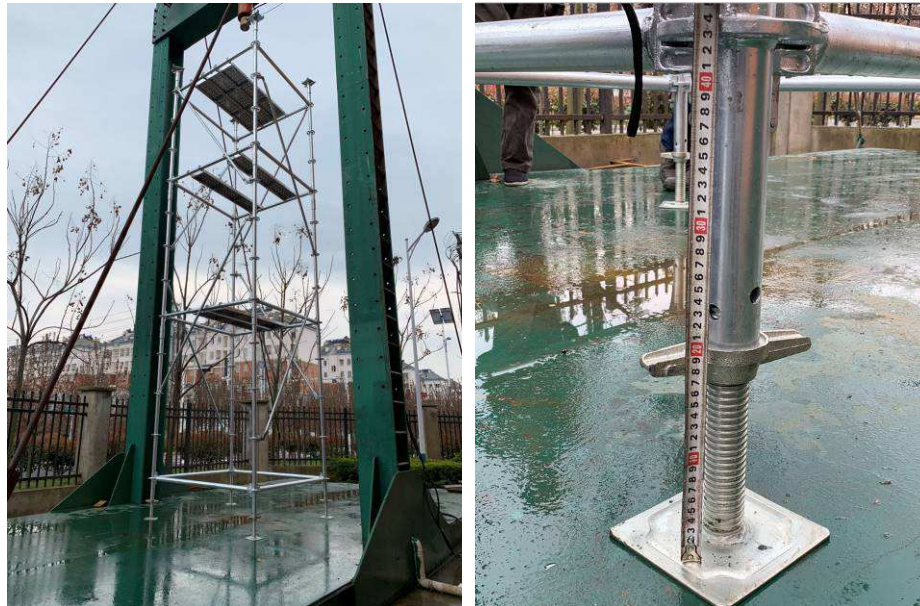
## 2. Sample installation and sample photo(s) before test:

The scaffold system for test is assembled as per customer's requirement as shown in the following picture. It is installed with one bay wide and one bay long, by three lifts high. The scaffold is consists of four vertical stand columns with adjustable leg extended to 200mm and with ringlock bracing installed all around during test.

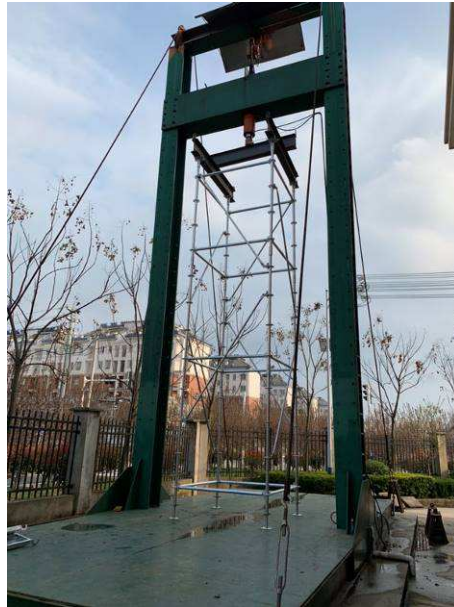
Apply a vertical load distributed to the four stand columns via steel I-beams shown as following, increase the test load progressively at a rate of 0.5kN/s till the scaffold system shows visible structural failure, record the maximum load.

During test

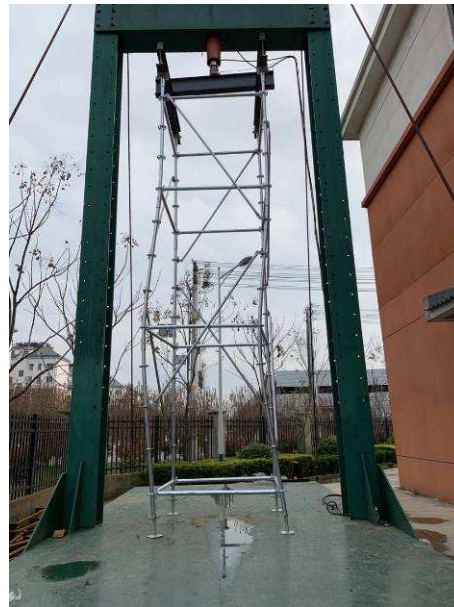
Test height	Maximum load (kN)	Maximum load per leg (kN)	Failure mode
6.2m	153.0	38.25	The stands were bent and the load cannot be increased usefully.

After test
