Test Report No.: 01 220 CHN/T-2403442-3

Test Report

Sample name: SWIVEL COUPLER

Other information: Product specification: Φ48.3mm;
Material and Mark: Q235.

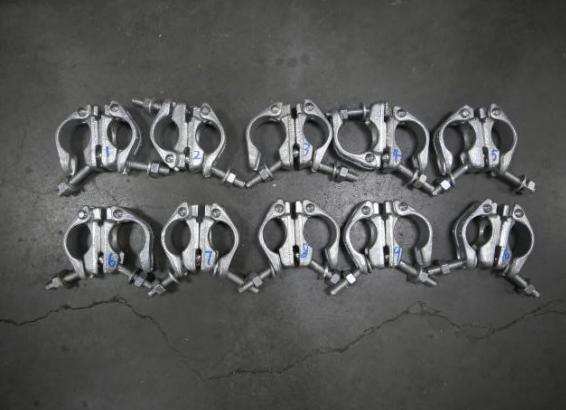
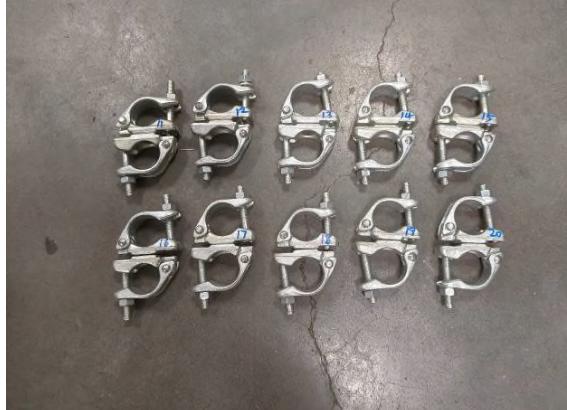
3#-1~10	3#-11~20

Sample description: A batch of swivel couplers

Sample photo(s):

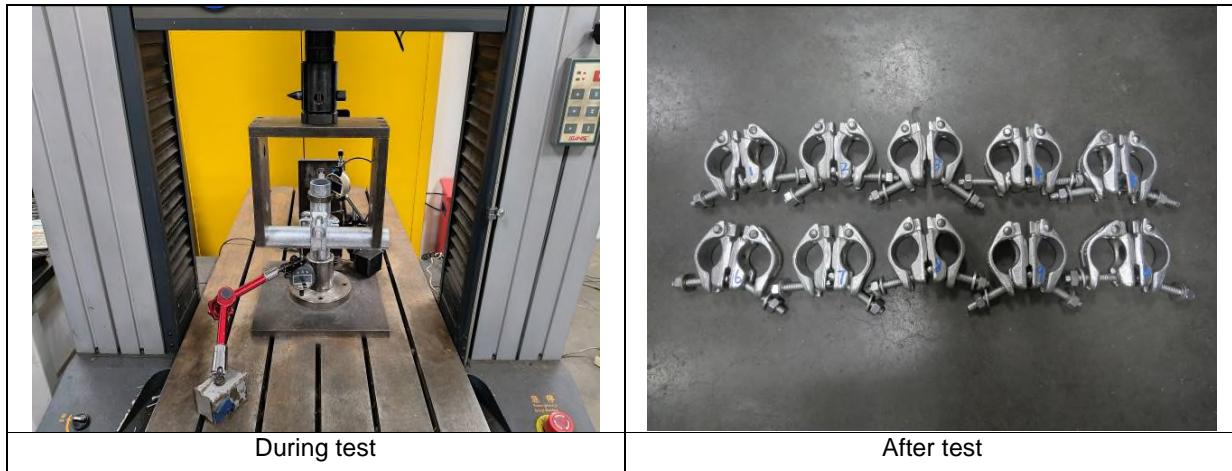
3.1 Slipping force:

Test method: EN 74-1:2022

Specification of steel tube: $\Phi 48.3\text{mm} \times 3.2\text{mm}$ (wall thickness)

Loading rate: 2mm/min (before beginning to slip: 0.3kN/s)

Sample	F_s (kN, $\Delta_1 \leq 7\text{mm}$)	F_s (kN, $1\text{mm} \leq \Delta_2 \leq 2\text{mm}$)
3#-1	13.17	$F_s = 20.0$, $\Delta_2 < 1\text{mm}$
3#-2	10.54	$F_s = 20.0$, $\Delta_2 < 1\text{mm}$
3#-3	12.56	$F_s = 20.0$, $\Delta_2 < 1\text{mm}$
3#-4	11.09	$F_s = 20.0$, $\Delta_2 < 1\text{mm}$
3#-5	9.17	$F_s = 20.0$, $\Delta_2 < 1\text{mm}$
3#-6	10.49	$F_s = 20.0$, $\Delta_2 < 1\text{mm}$
3#-7	13.01	$F_s = 20.0$, $\Delta_2 < 1\text{mm}$
3#-8	10.75	$F_s = 20.0$, $\Delta_2 < 1\text{mm}$
3#-9	10.20	$F_s = 20.0$, $\Delta_2 < 1\text{mm}$
3#-10	10.15	$F_s = 20.0$, $\Delta_2 < 1\text{mm}$
$F_{s,5\%}$	8.6	$F_s = 20.0$, $\Delta_2 < 1\text{mm}$

Note: When the test load reached twice the specified F_s given in Table 8 of EN 74-1:2022, the test could be ended according to the standard.

Test item	Test requirement (EN 74-1:2022 Class A)	Test result	Conclusion
Slipping force	$\Delta_1 \leq 7\text{mm}$, $F_{s,5\%} \geq 7.0\text{kN}$	$F_{s,5\%} = 8.6\text{kN}$	Pass
	$1\text{mm} \leq \Delta_2 \leq 2\text{mm}$, $F_{s,5\%} \geq 10.0\text{kN}$	$F_s = 20.0\text{kN}$, $\Delta_2 < 1\text{mm}$	
Failure force	$F_{f,5\%}/\gamma R2 \geq 14.0\text{kN}$	$F_{f,5\%}/\gamma R2 = 22.9\text{kN}$	Pass
Indentation	$F = 4.7\text{kN}$, $\Delta_{10} \leq 1.5\text{mm}$	$F = 4.7\text{kN}$, $\Delta_{10} < 1.5\text{mm}$	Pass

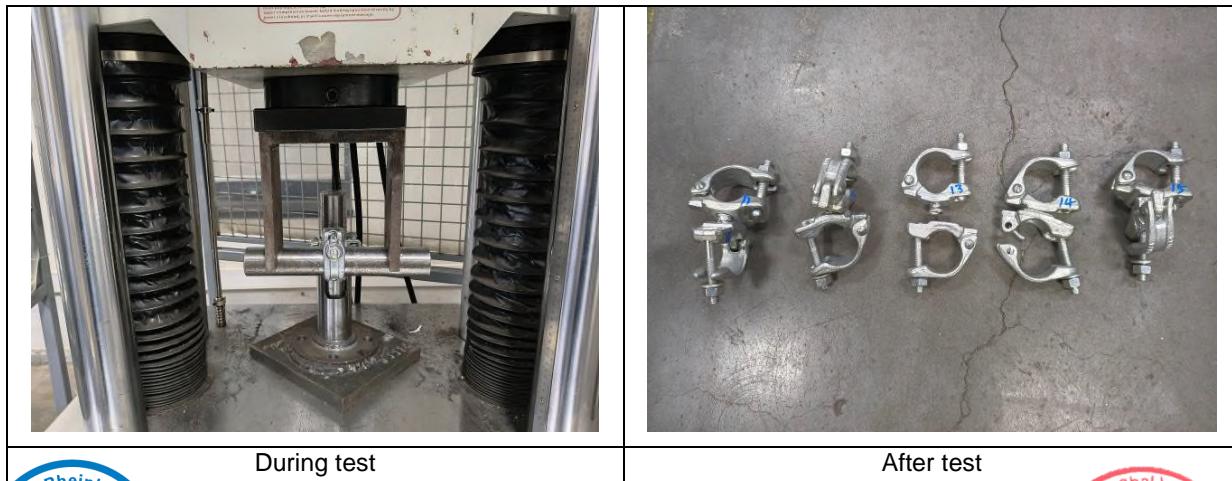
3.2 Failure force:

Test method: EN 74-1:2022

Specification of steel bar: Φ48.3mm

Loading rate: 2mm/min

Sample	F_f (kN)	Failure mode
3#-11	37.03	The center rivet was broken.
3#-12	36.24	The center rivet was broken.
3#-13	44.09	The center rivet was broken.
3#-14	33.25	The rivet was ruptured.
3#-15	43.03	The bolt was ruptured.
$F_{f,5\%}/\gamma R2$	22.9	/

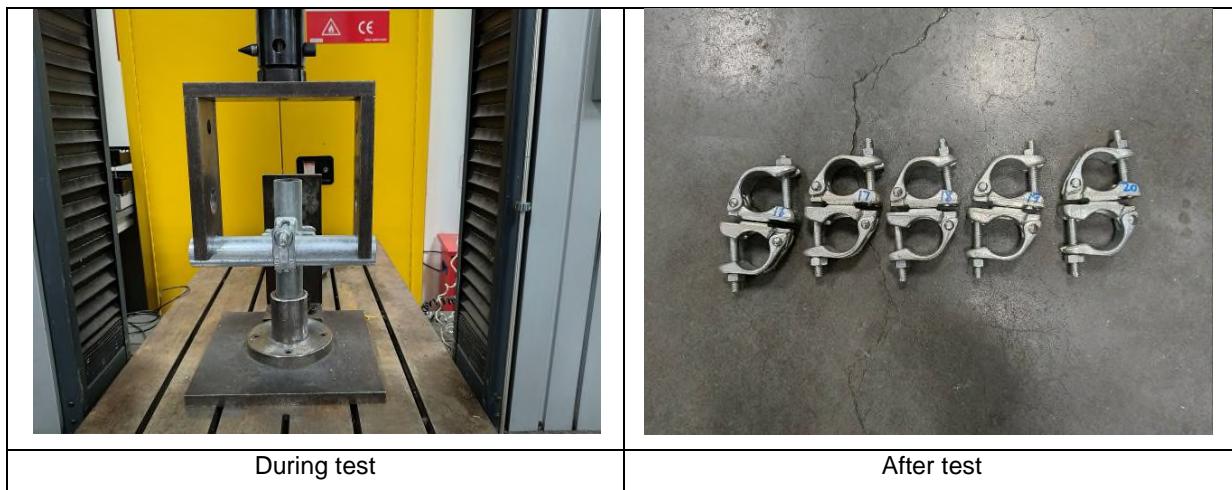
3.3 Indentation:

Test method: EN 74-1:2022

Specification of steel tube: Vertical tube: $\Phi 48.3\text{mm} \times 2.8\text{mm}$ (wall thickness)

Horizontal tube: $\Phi 48.3\text{mm} \times 3.2\text{mm}$ (wall thickness)

Loading rate: 2mm/min

Sample	Δ_{10} (mm, $P_{ind}=4.7\text{kN}$)
3#-16	0.12
3#-17	0.07
3#-18	0.15
3#-19	0.08
3#-20	0.13
