TEST REPORT

No. : SHIN2510002641CM04_EN

Sample Name : CANTILEVER BEAM COUPLER

Product Specification : 48.3mm

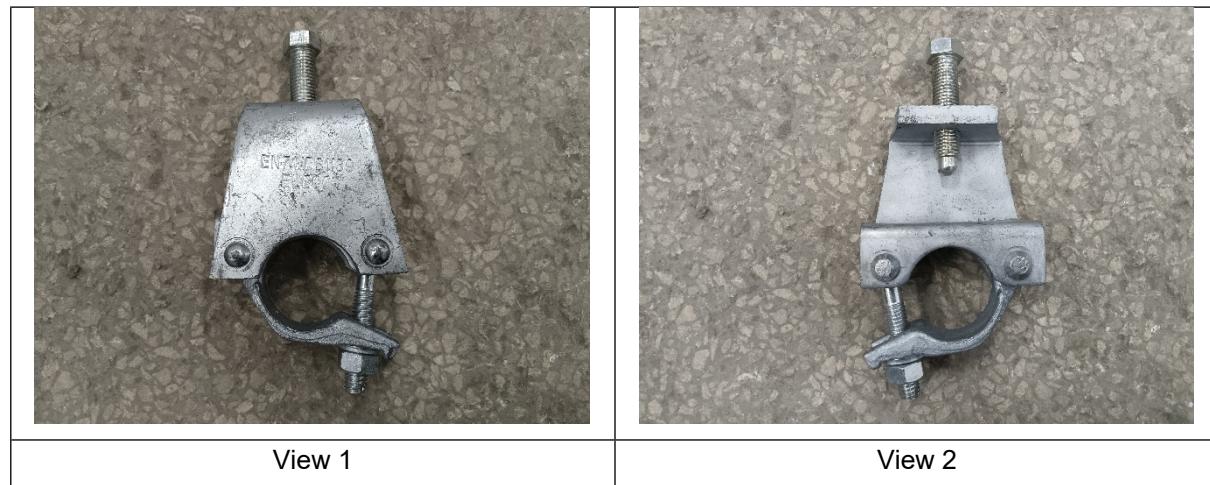
Original Sample Photo(s):

Material : Q235B
